# Floor Receptacle Circuit Repair

RESIDENTIAL ELECTRICAL REPAIR

LOCATION: BENEATH A MOBILE HOME

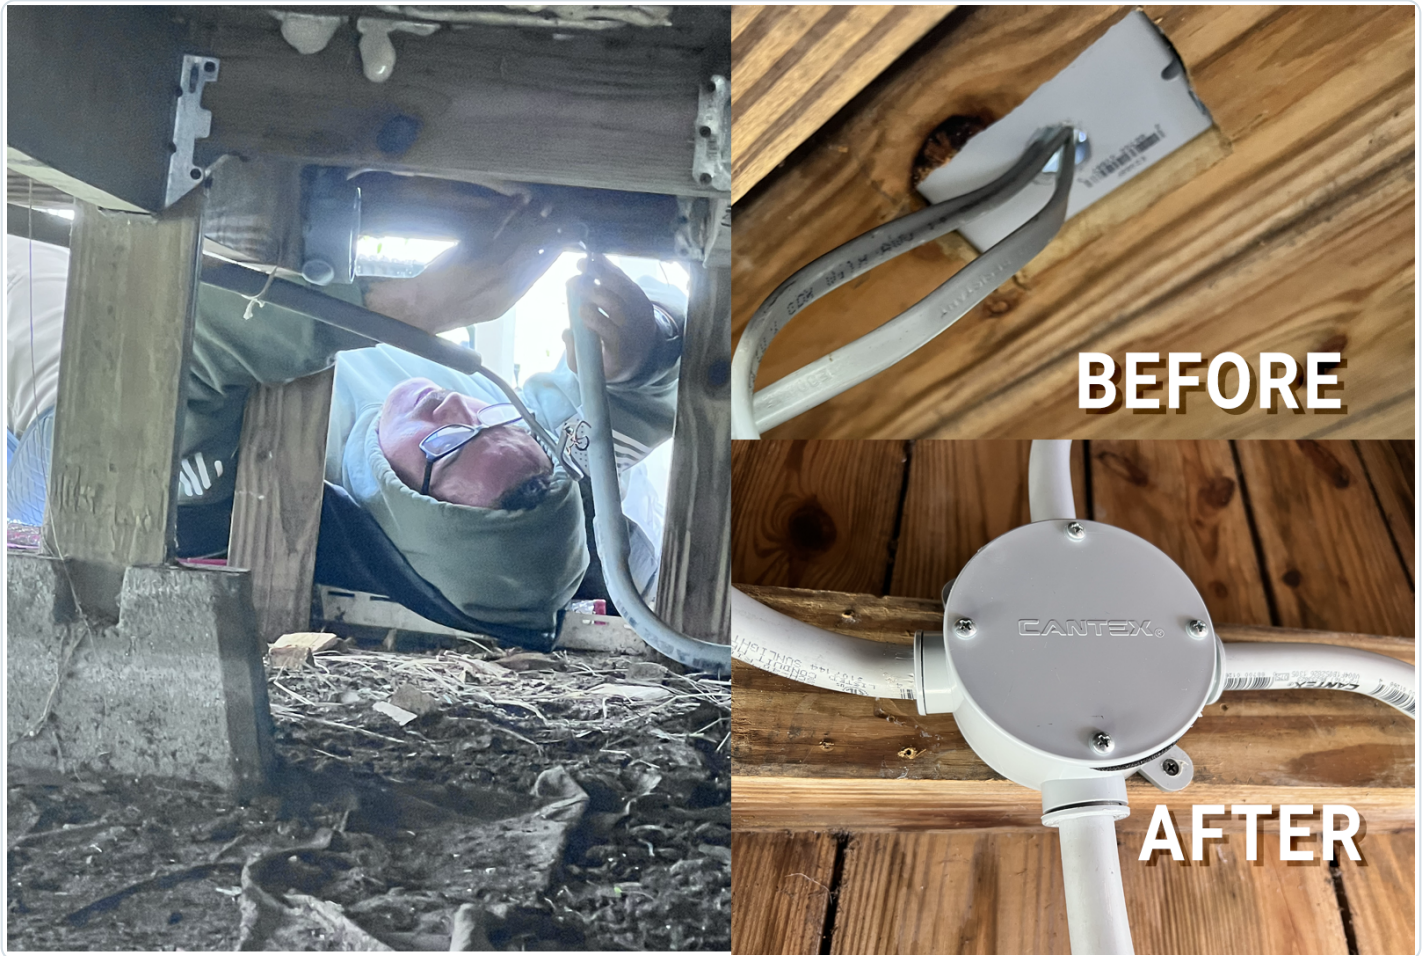
I repaired a circuit serving three floor receptacles powering a window A/C unit and refrigerator beneath a mobile home. Voltage drop and poor performance were traced to the original daisy-chained installation. I added an accessible junction box and reconfigured the circuit with proper pigtail connections so each receptacle is wired in parallel.

I secured the conduit, corrected exposed wiring, and replaced improperly installed wall-style outlets with 20-amp tamper-resistant, weatherproof floor boxes equipped with protective covers and USB charging ports. After installation, I tested the system to confirm proper voltage, grounding, polarity, and improved appliance operation.

● VERIFIED: Voltage | Grounding | Polarity | Appliance operation
